Report

Impact assessment of soil and water conservation measures at Medego watershed in Tigray, northern Ethiopia

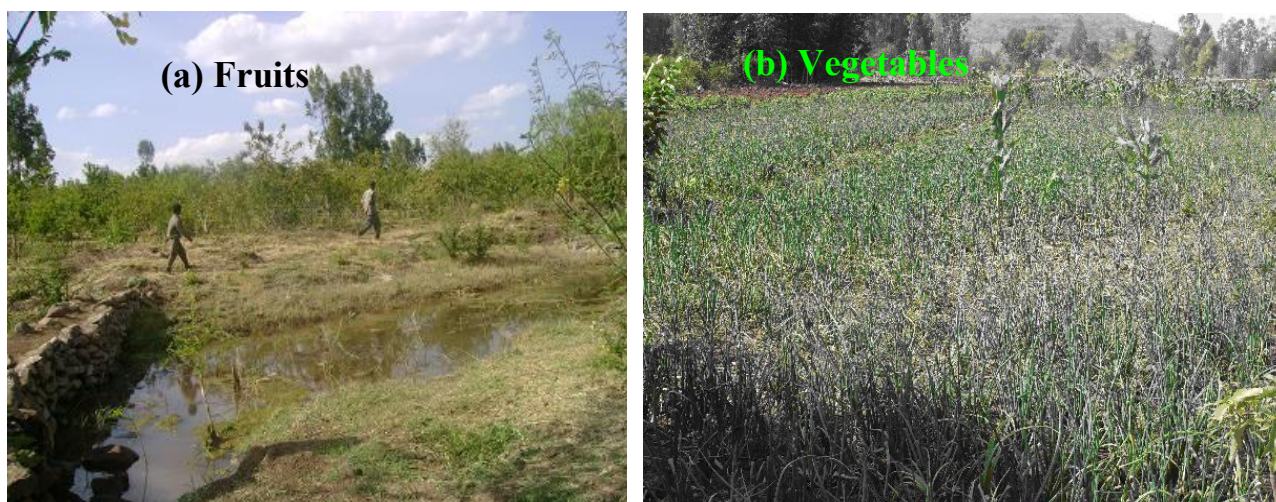
Figure 2. Small-scale irrigation expansion: (a) fruits; (b) vegetables intercropped with maize after implementation of SWC measures using water retained in check dams and shallow and deep wells (March 2008)

According to our field observation, some of the check dams constructed in both the up-stream and down-stream parts of the landscape collapsed due to faulty construction. There was less tendency to integrate the physical and biological SWC measures, particularly in the up-stream part of the watershed. Most respondents (80%) felt that the Bureau of Agriculture as well as the Food for Work campaign program coordinators did not give enough follow-up and monitoring of check dam maintenance. The local community did not adopt participatory feelings to repair these community resources. In spite of this, many farmers believed that they had benefited much from check dams constructed in the watershed. Some of the farmers (~30%) planted vegetable crops such as tomato, potato, onion and carrot as well as citrus with water accumulated on the check dam floor (Figure 2). Farmers not having land near a water supply used shallow and deep wells with increased ground water as a result of improved soil conservation measures.

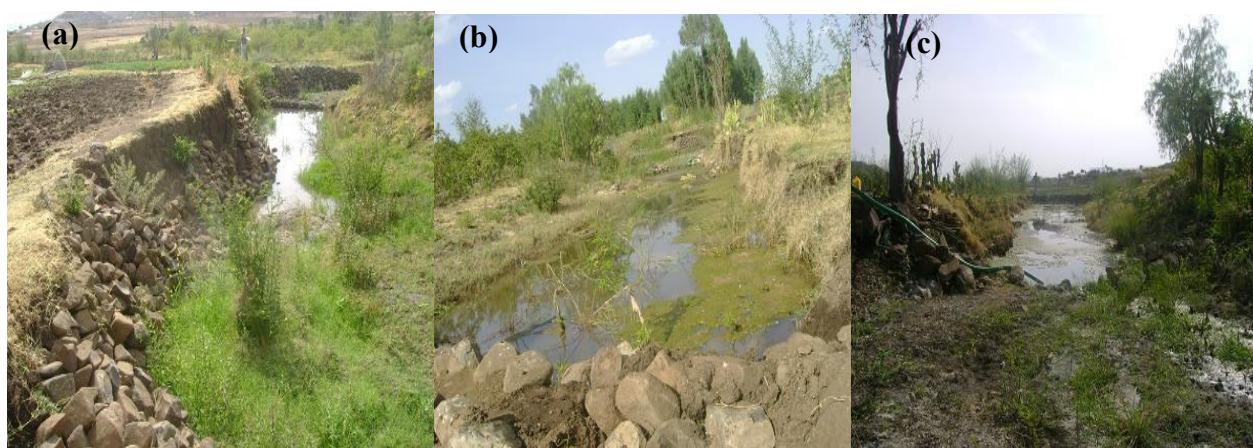
Figure 4. Water resources developed and used for small-scale irrigation and other purposes as a result of long-term impact of the SWC measures implemented in the Medego watershed: (a) deep gully rehabilitated; (b) shallow but wide gully rehabilitated; (c) deep and wide gully after rehabilitation (January 2008)

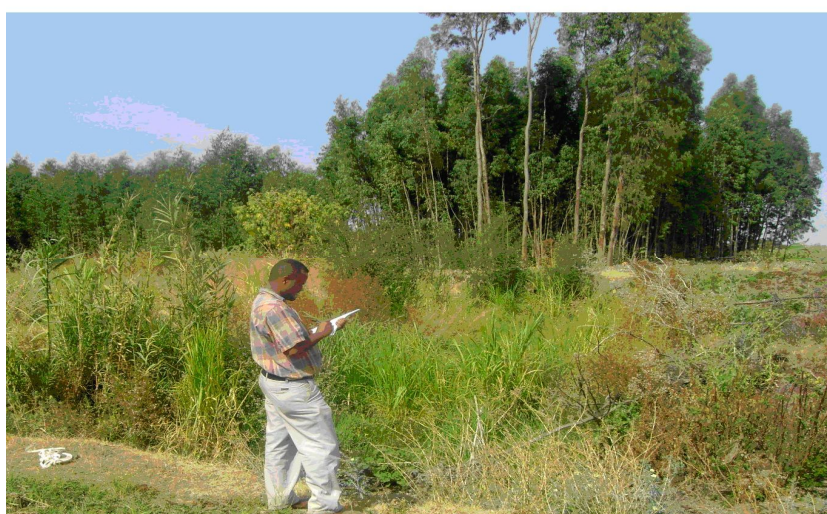
Figure 5. The impact of SWC measures on greenness, increasing biomass and climate improvement after gully rehabilitation in the Medego watershed (February 2008)

After the implementation of different SWC measures, especially check dams in gullies and bunds in steep streams, the climate of the area improves as a result of increasing vegetation cover (Figures 2-5). The respondents confirmed that the hot and dry air that previously dominated the watershed has been replaced by moist and cooler air. This is because by of increasing vegetation cover in the catchment, which is a direct reflection of the improvement of available water and soil fertility in the area. More biomass after SWC conservation measures has resulted (Figure 5). The vegetables and fruits cultivated in irrigated fields in the watershed have also contributed towards the greenness and humidity in the area.
